MASONRY MORTAR TECHNICAL NOTES # 4

# EFFLORESCENCE OF MASONRY

ROBERT S. BOYNTON  
KENNETH A. GUTSCHICK

NATIONAL LIME ASSOCIATION  
3601 N. FAIRFAX DRIVE  
ARLINGTON, VA 22201

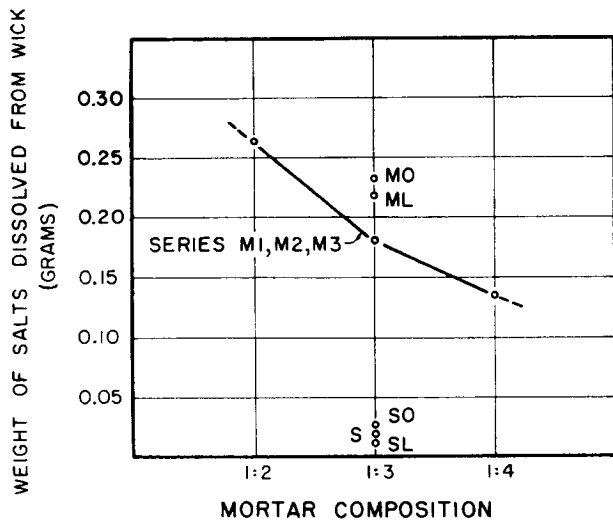
Fig. 5. Comparison of amounts of salts dissolved from wicks used with mortars of masonry cements M and S and various sands for different ratios by volume of cementing material to sand.

less efflorescence than another cement with the same lime, sand, and equivalent proportion. Similarly, as Fig. 5 depicts, the two masonry cements behaved completely differently: one (the M series) generated heavy efflorescence; the other (the S series) had scarcely any. Invariably, the greatest efflorescence stemmed from those mortar materials possessing the greatest amount of alkali salts (see Table I).

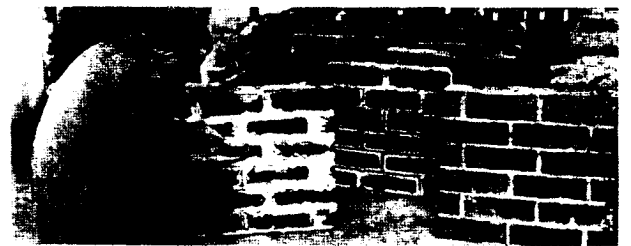
Researcher scrapes off some of the powdery crust (efflorescence) from a test brick panel. The substance was identified as soluble alkali sulfates, particularly those of sodium and potassium.
